**Re: Freedom of Information Act Request  
Private Water Supply Sampling  
Markham, Illinois**

**Weaver Consultants Group North Central, LLC** is requesting the analytical data for private water well sampling conducted in the vicinity of the property located at the southwest corner of 160<sup>th</sup> Street and Dixie Highway in Markham, Illinois. The Property is located south of 160<sup>th</sup> Street, west of Dixie Highway, north of the Calumet Union Drainage Ditch, and east of Western Avenue, as identified in the attached map. The Property is located within the northwest quarter of Section 19, Township 36 North, Range 14 East of the Third Principal Meridian in Cook County, Illinois.

**SUBJECT:** 0311775095 - Cook Co.  
Request for Approval and Funding for a Time-Critical Removal Action at the  
Markham Dump Site, Markham, Cook County, Illinois (Site ID # B5WK)  
FOS

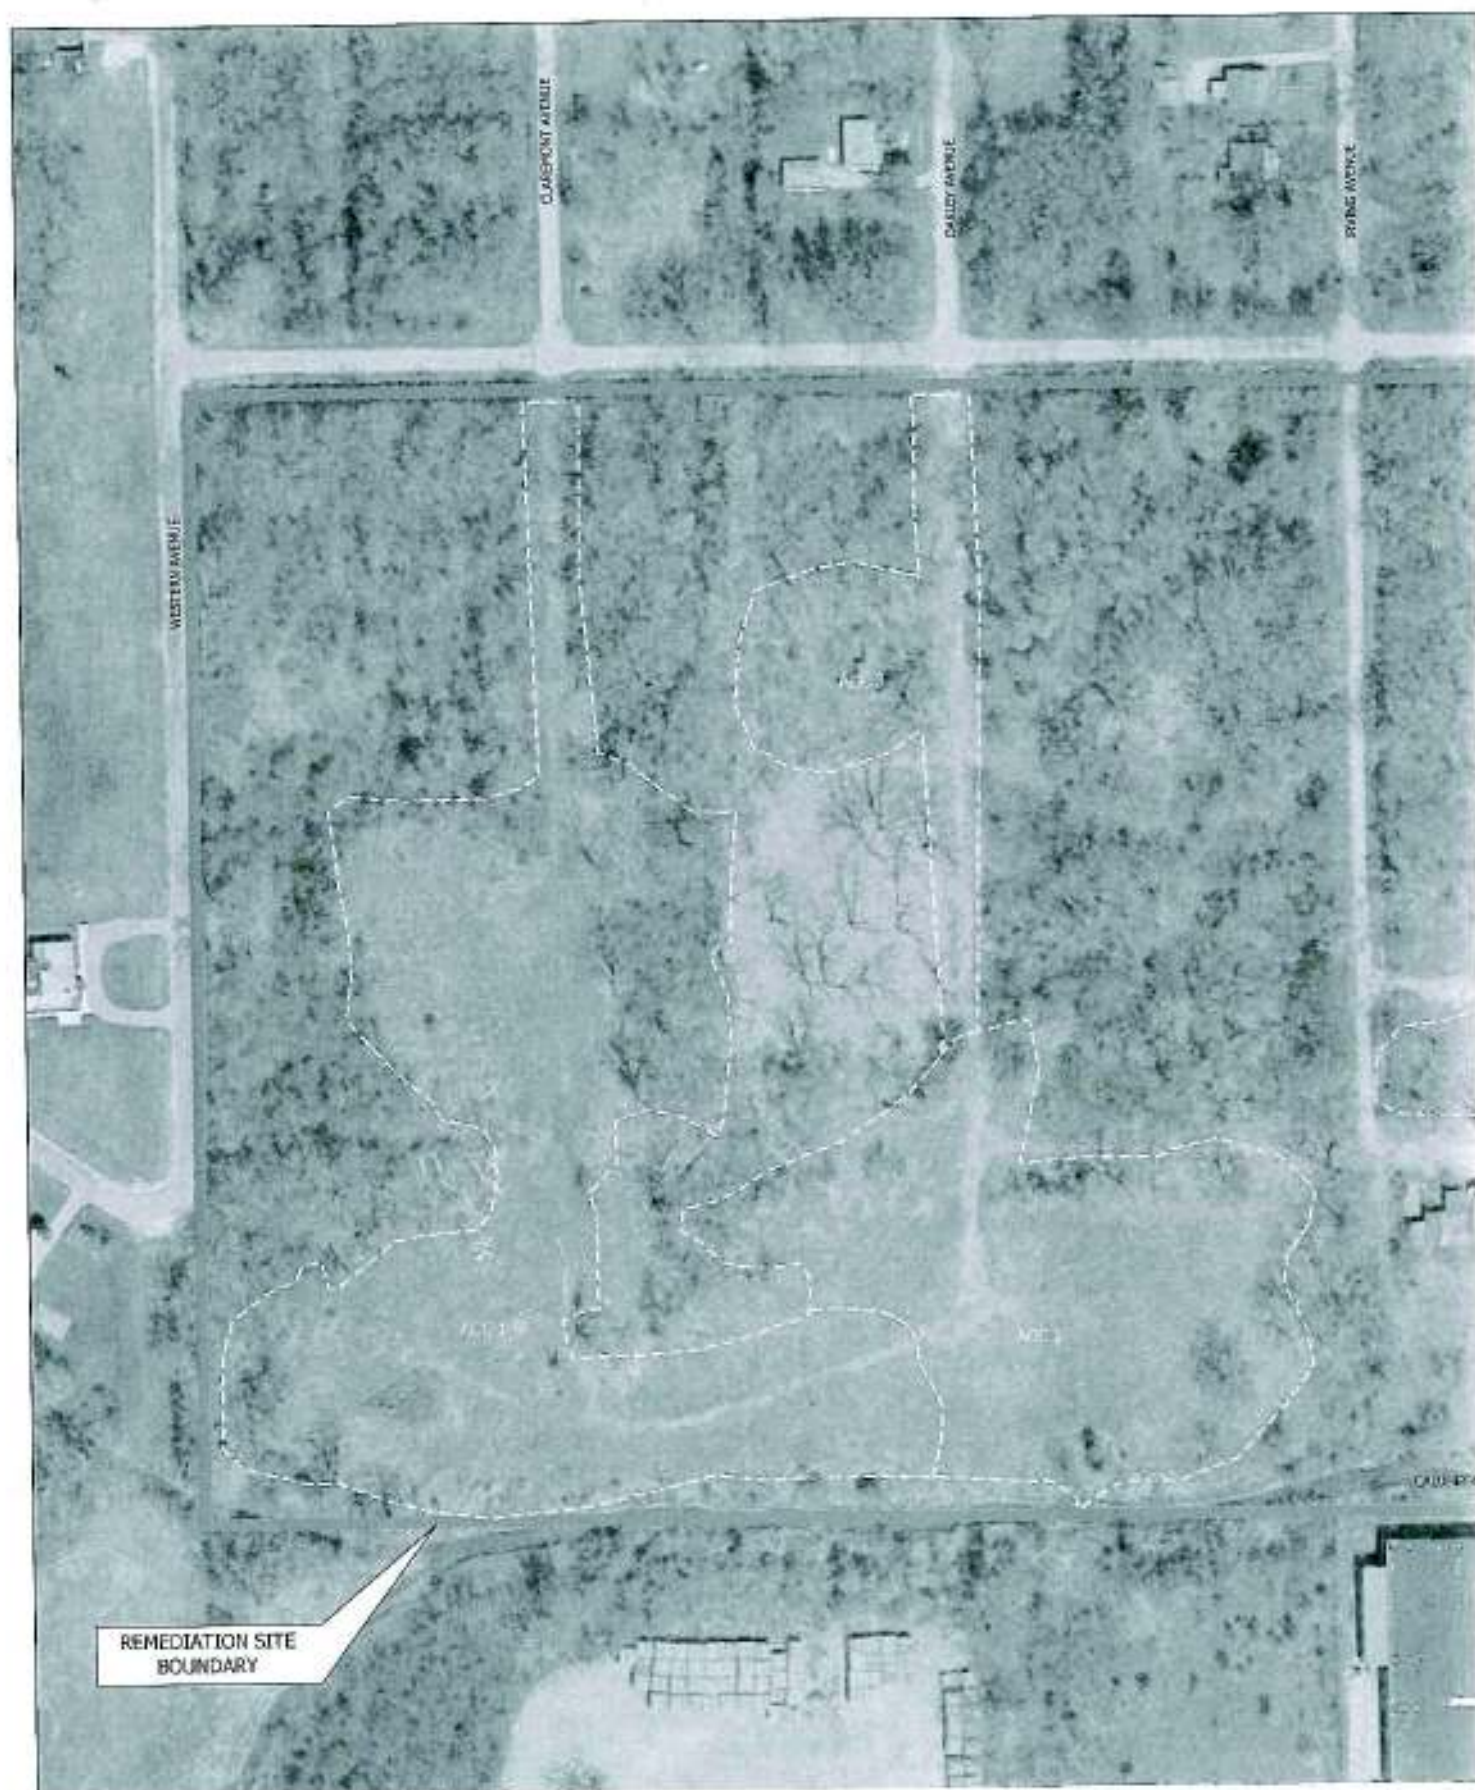
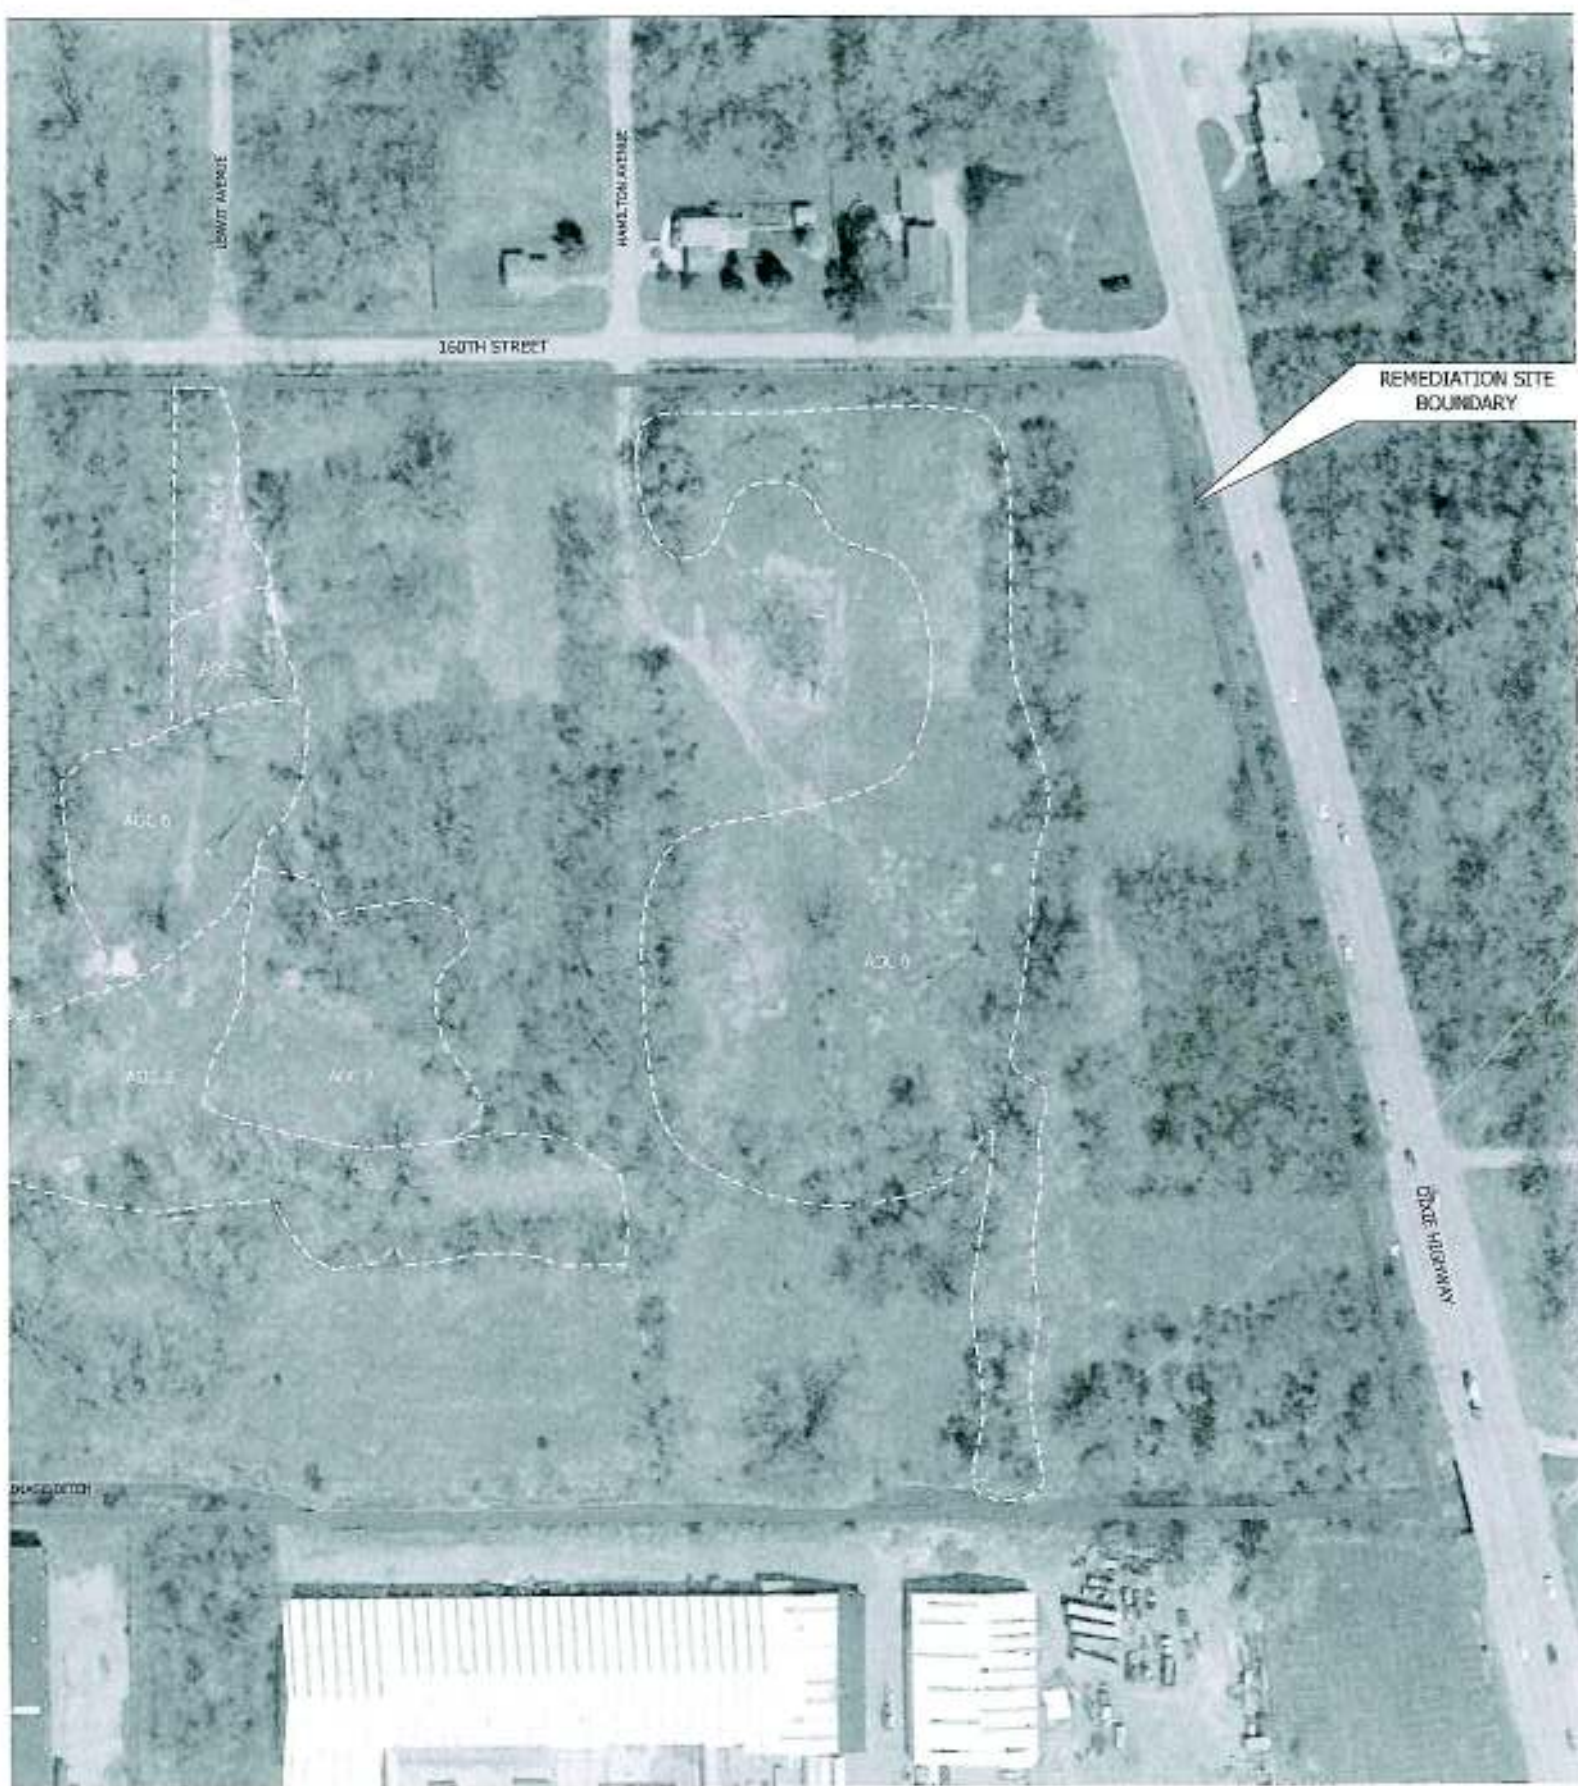
REMEDIATION SITE  
BOUNDARY

AREAS OF DIRT PILES (AOC 8), BURNED TIRES AND WASTE (AOC 1) FROM OTIE AND IEPA.

AREAS OF AOC 8 MODIFIED FROM OTIE AND IEPA BASE ON MARCH 8, 2016 SITE VISIT.

APPROXIMATE LOCATION OF WASTE AND ENVIRONMENTAL RESPONSE ACTIONS
